24th DOE/NRC NUCLEAR AIR CLEANING AND TREATMENT CONFERENCE

POTENTIAL FOR HEPA FILTER DAMAGE FROM WATER SPRAY SYSTEMS IN FILTER PLENUMS*

Werner Bergman, Jan K. Fretthold¹, and James W. Slawski²
Lawrence Livermore National Laboratory
Livermore, CA 94550

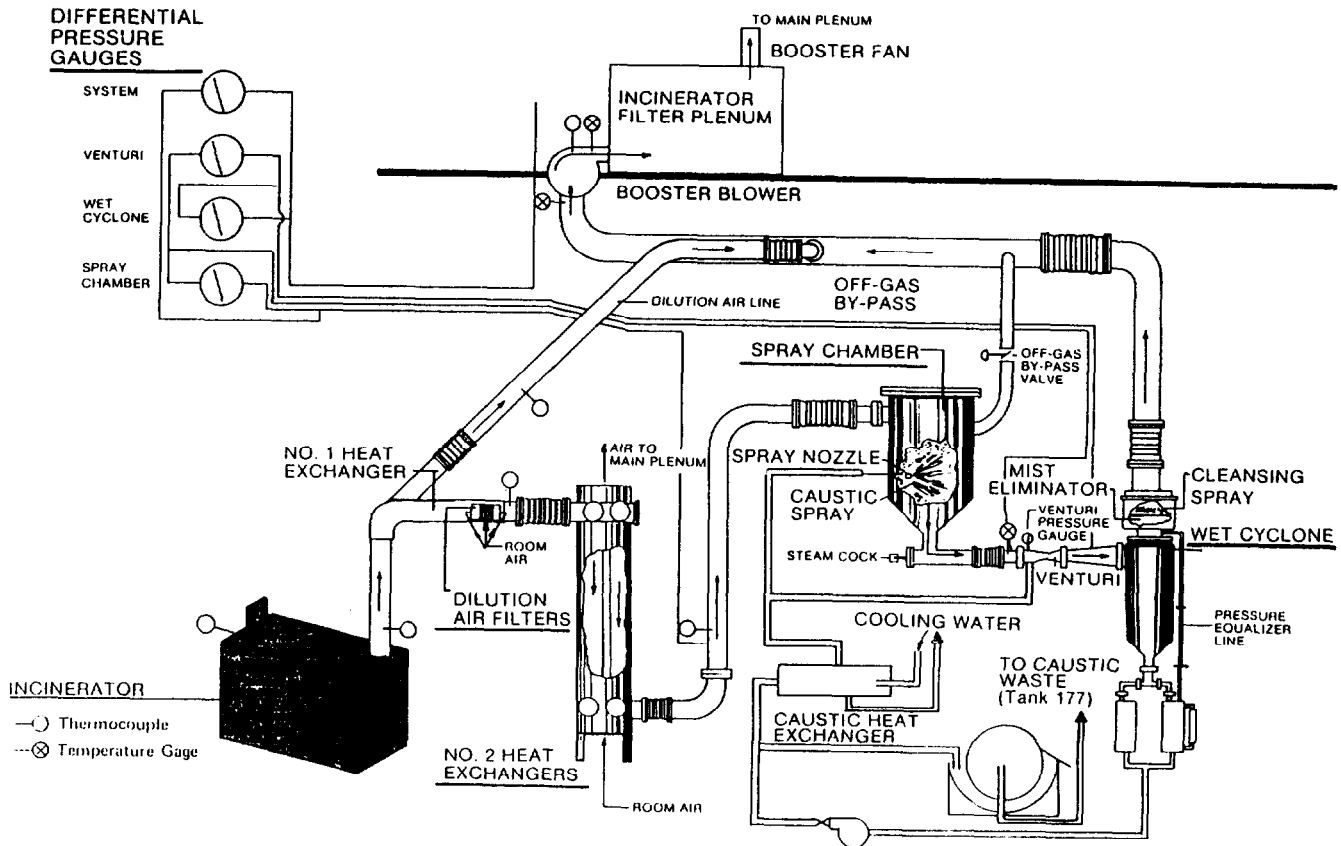
Figure 6. Schematic of the incinerator off-gas treatment system

The investigation following the fire concluded that the primary cause of the fire was the deteriorated off-gas bypass valve on the spray chamber shown in Figure 6.⁽²⁾ The untreated hot exhaust was able to bypass the off-gas treatment and enter directly into the HEPA filter plenum. This raised the gas temperature at the plenum inlet to a maximum 180°C (356°F). In addition the investigators speculated that nitric and hydrochloric acids in the exhaust may have reacted with the urethane foam sealant used on the HEPA filters and raised the temperature even further.⁽²⁾ The investigators also found metal oxide powders consisting of Cr, Fe, and Ni and as well as chlorates and nitrates on the filter media. Because the metal on the filter suggest their origin was stainless steel, the investigators concluded "This is an indication that the stainless steel duct work is being corroded by the acidic environment." From this, the investigators concluded that "All of these very fine metal particles collected on the filter media are capable of supporting combustion" and was responsible for igniting the HEPA filters.⁽²⁾

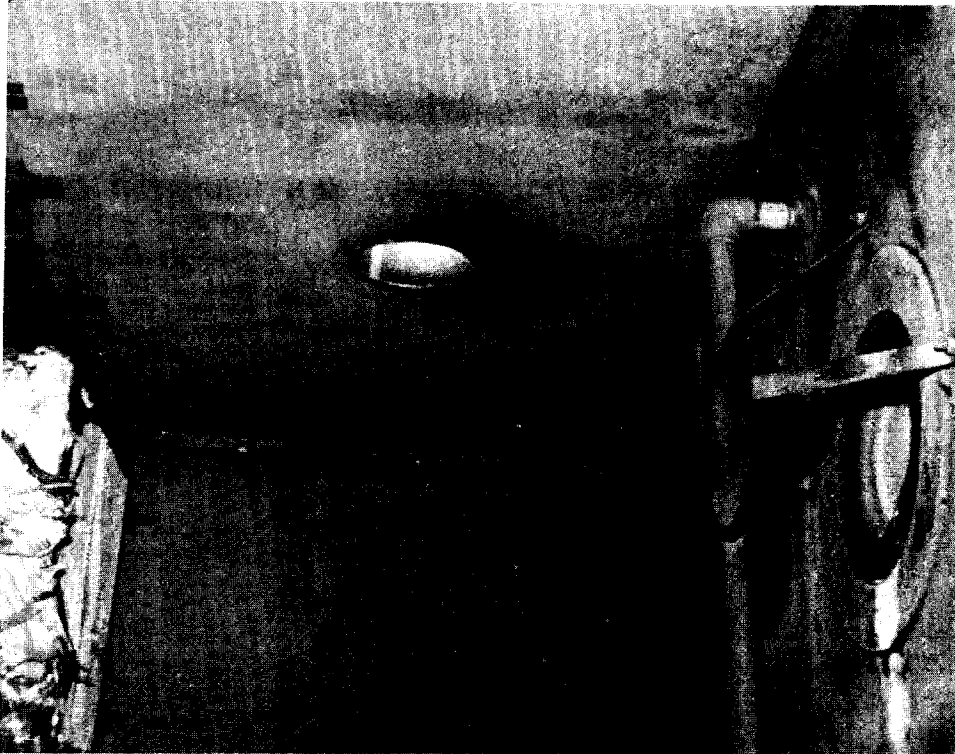
Figure 8. Photograph inside the front chamber of the filter plenum showing the air inlet with deflector cone and the damaged first stage HEPA filters.

The second fireman arrived later and stated that he had entered the upstream plenum room (Figures 8 and 9) and saw the entire filter bank had been destroyed.⁽¹⁸⁾ He did not spray any water on the first stage filters because there was no remaining fire. On entering the second door (Figures 10-13), he saw HEPA filters on fire and sprayed them with the water fogger. He stated that his spraying caused no further structural damage to the filters. He then entered the exhaust plenum, but since there was no fire and the HEPA filters were not damaged (Figure 14), he did not spray the filters.⁽¹⁸⁾

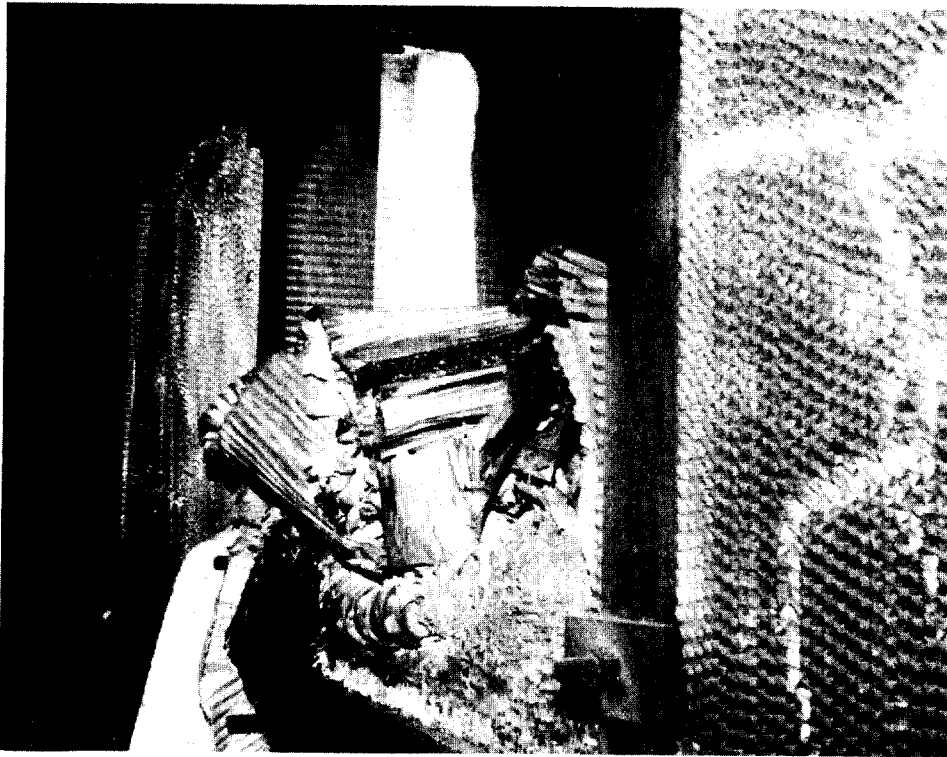
Figure 10. Photograph inside the middle chamber of the filter plenum showing the rear side of the 2nd stage HEPA filters.

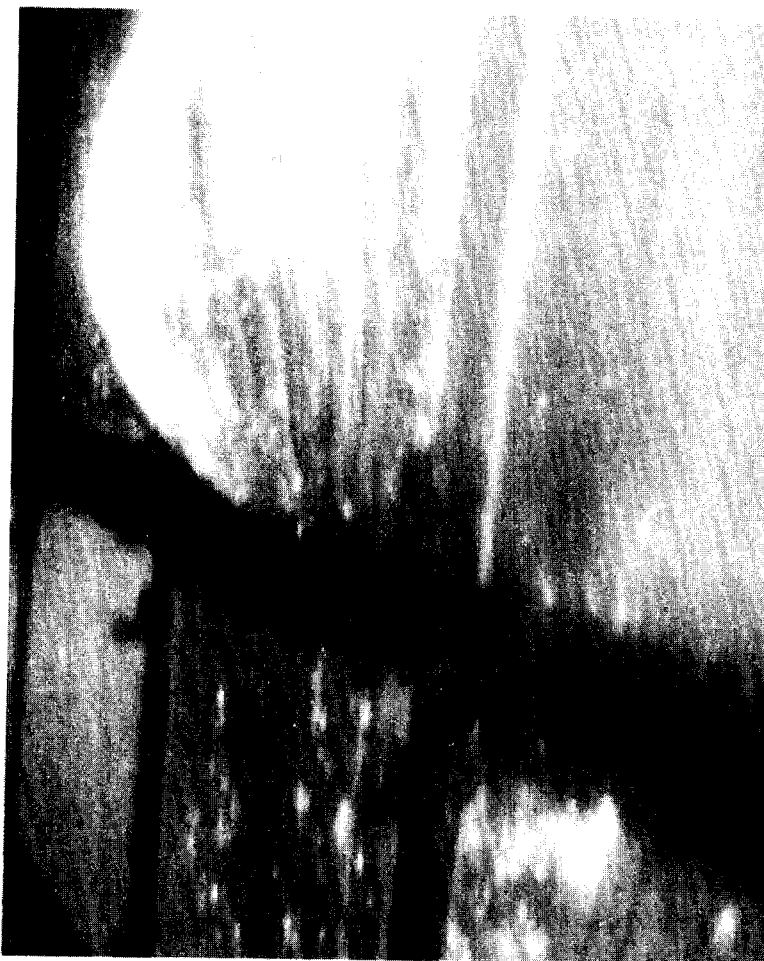
Figure 14. Photograph of the rear side of the 4th stage HEPA filters.

The final filter bank was not destroyed, although some of the HEPA filters had severely bowed, as shown in Figure 14. The final HEPA stage would have experienced a lower temperature and far less water exposure than the first three banks. If the urethane sealant on the bowed HEPA filter in Figure 14 were burned out, then it would take less force to push out the HEPA pack because the top portion would be loose and not attached to the filter frame. The fact the filter pack is not blown out, but bowed, indicates the top urethane sealant was still holding the media pack to the filter frame.
