Mitigation of the Effects of the U1 Steam Leak  
on U2 Outage & Turbine Building Operations  
Peter G. Dorosko, PE  
Carolina Power & Light  
Brunswick Nuclear Plant  
Southport, North Carolina, 28461-0429

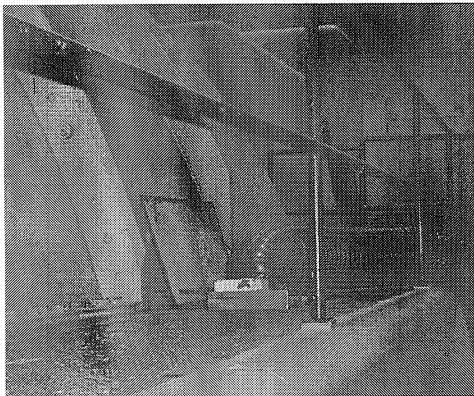
Figure 1

Outlet point from under U1 Turbine

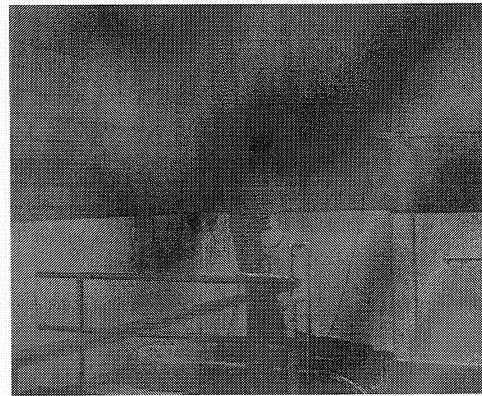
Figure 2

HEPA hose routed over the shield wall

A leak-off line for condensate was added between the outlet from under the turbine and where the hose goes over the shield wall. When the hose became blocked with condensate, the activity levels rose quickly in the turbine building.

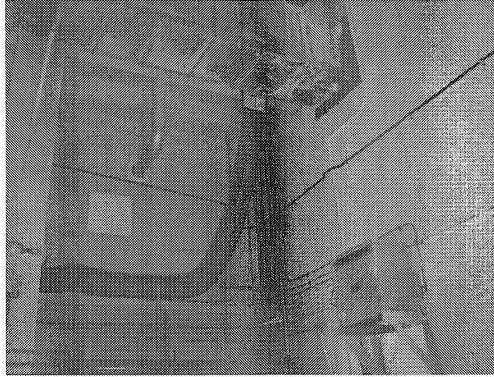
Figure 3

Portion of HEPA hose coming over shield wall from under the turbine

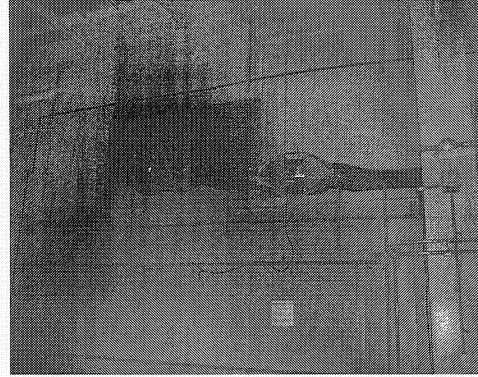
Figure 4

Blower and inlet to the exhaust fan room

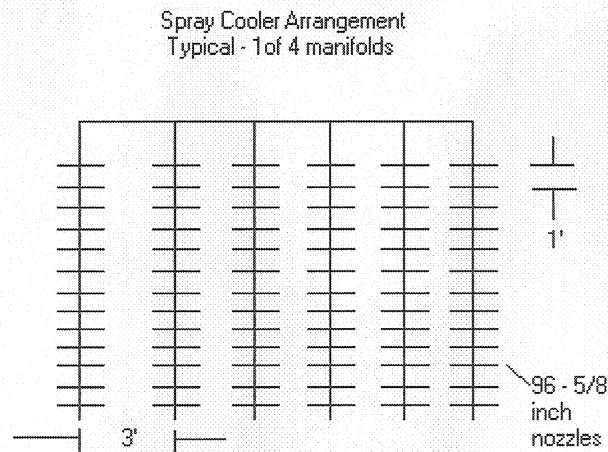
Figure 5

Once the effluent was routed into the ventilation system it passed through the spray cooler arrangement illustrated below. The spray manifold consists of a four sections containing 6 two inch diameter pipes with 96 nozzles. The flow rate through this spray system is approximately 2000 gpm.

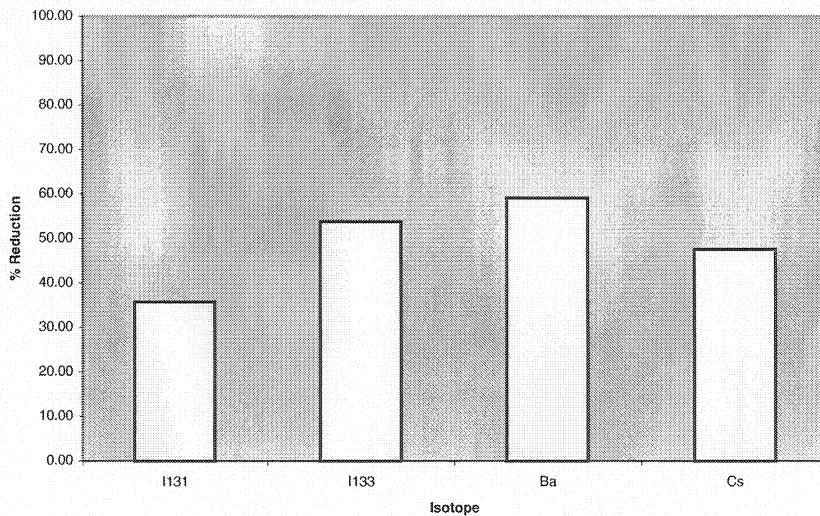
Graph 1, Reduction in Airborne Activity

As can be seen in the following graph, there was a significant reduction in airborne activity. Depending on the isotope, the reduction was between 35% and 60%.

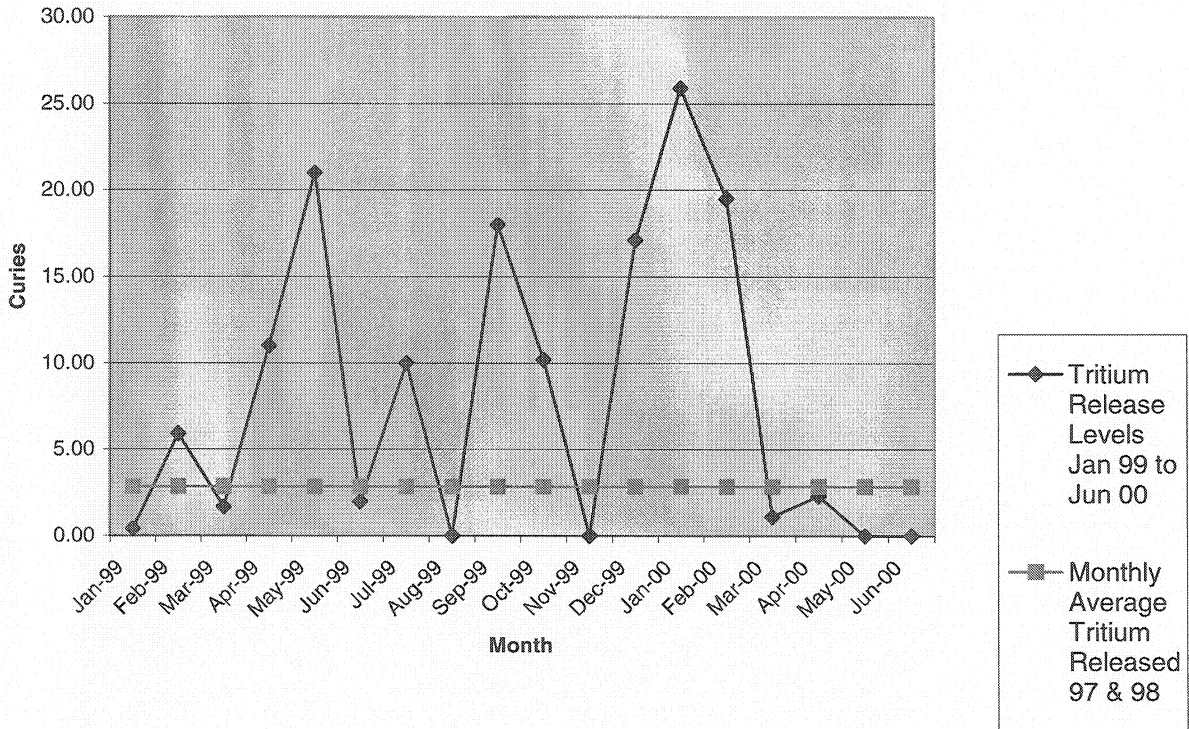
Graph 2, Radiological Liquid Tritium Released

Another indication of the affect of the scrubbing by the spray wash sub-system of the Turbine Building ventilation system was the increase in the level of tritium being released from the plant. As part of the ventilation system, water that overflows from the chill water basin is routed to a holding pond. It is sampled and then released in the discharge canal for the condenser cooling water. The average liquid tritium released for 1997 and 1998 was 2.3 curies per month. The level increased to approximately an average of 10 curies per month. There are large swings in the amount of radiological tritium released in a given month because it is controlled based upon the activity level in the holding pond and the level of the pond.
