**IN SITU REMEDIATION OF PLUTONIUM FROM GLOVEBOX EXHAUST
DUCTS AT THE DEPARTMENT OF ENERGY ROCKY FLATS PLANT**

J.S. Dugdale, J. K. Fretthold, T. J. Humiston, and G. E. Omer
Rocky Flats Environmental Technology Site
P O Box 464
Golden, Colorado 80402-0464

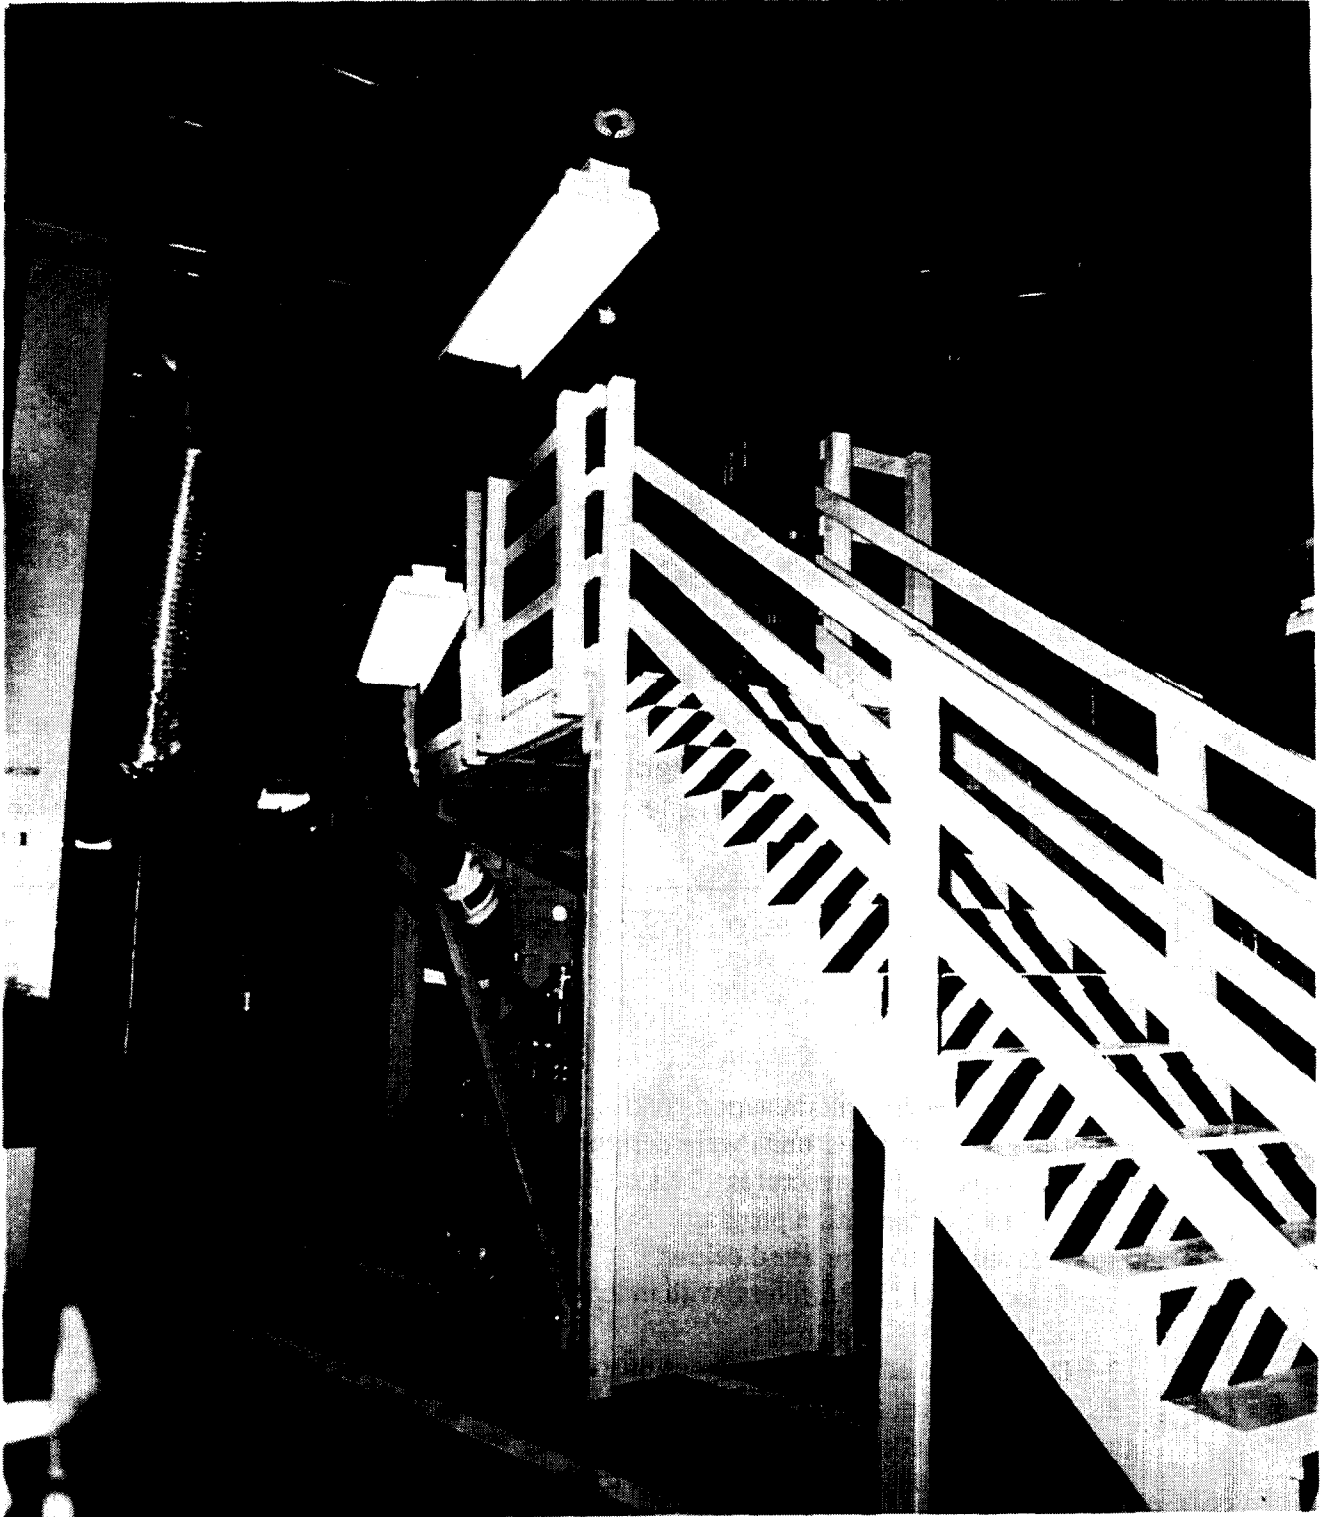
Fig. 18 Structure Access

Fig. 19 Structure

While the implementation of specialized tools and techniques provided significant material removal capabilities, some areas of ductwork were inaccessible by the above methods. Over one hundred meters of header piping could not be cleaned from the process gloveboxes. In order to remediate these areas, engineered access locations were developed. This involved installing a glovebox on a line, operating ventilation system without shutdown or loss of contamination control. These access locations had to adhere to many constraints, such as user operability, design requirements and standards, and space limitations. Operations personnel would spend up to six hours at a time, 12 hours per day in locations, thus the engineering design was driven primarily by human factors and usability considerations. These locations typically consisted of a glovebox which was “hot-tied” into the existing exhaust header by adjustable legs on a wooden platform, was enclosed by a hard walled contamination-containment structure. Figure 17 shows the relative configuration of a saddleport location and the surrounding structure. Figures 18 & 19.

The structure provided contamination control, largely through the use of airflow and cascading pressures. Airmover units were designed to establish and maintain the required working pressure within the structures. This equipment was built to newly established criteria for the Duct Remediation program. Some of the special features which were created to meet the criteria are listed below:
