# DECOMMISSIONING OF HEPA FILTER PLENUMS

J. K. Fretthold  
K-H Engineering Programs

Rocky Flats Environmental Technology Site  
Golden, Colorado 80403-8200

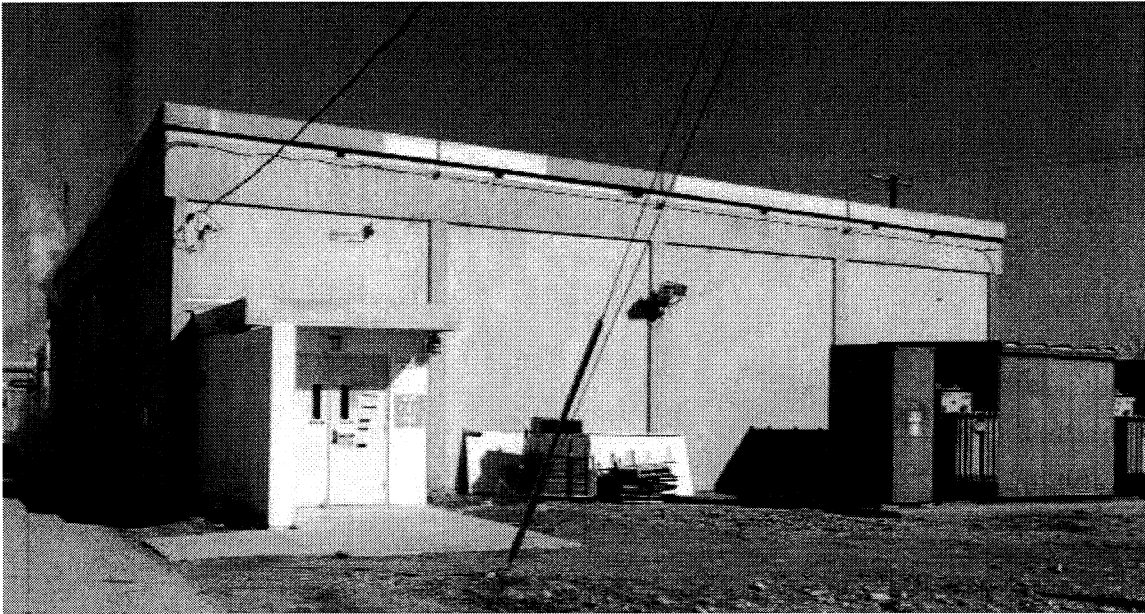
Building 782 (Photo 1) was a single-story building approximately 100ft. long x 62ft. wide by 16ft. high. Reinforced concrete caissons, varying from 2 ft. to 2½ft. in diameter and from 6ft. to 24ft. deep, supported reinforced concrete grade beams that are 10in. thick by 5ft. deep. Building 782 houses three exhaust plenums and one supply plenum (Figure 2) along with the fans, duct work, electrical equipment and supporting utilities. (Photos 2, 3, 4 and 5)

Photo 1 – Building 782

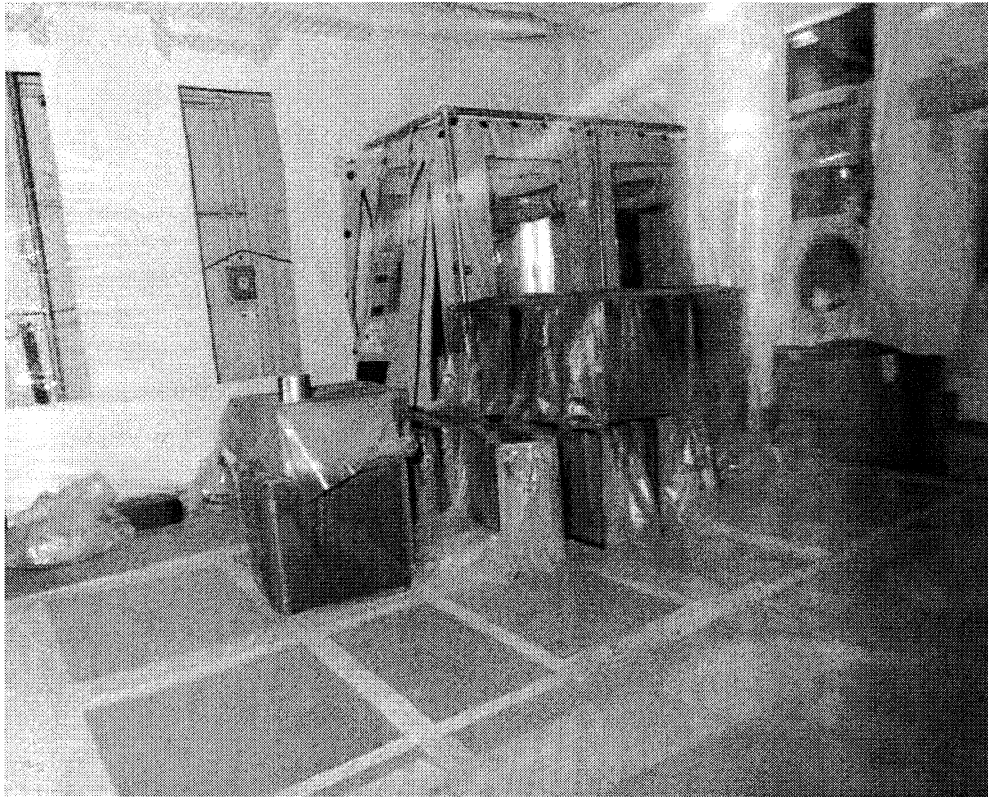
Photo 10 – Bagged HEPA Filters

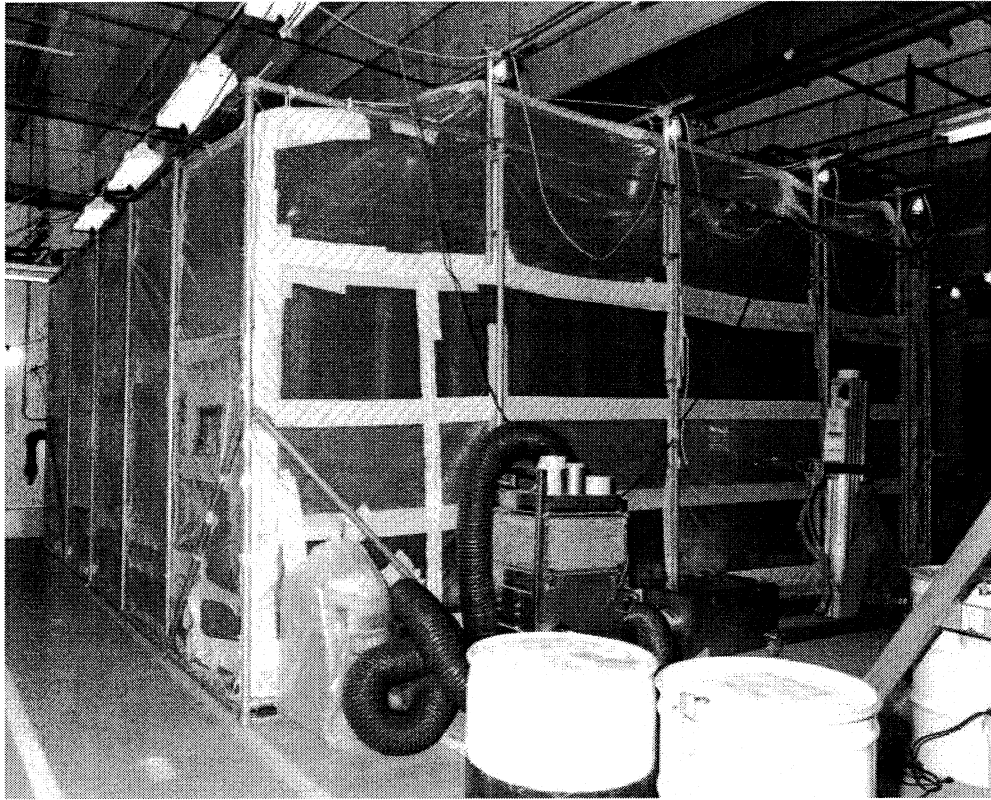
Photo 17 – Plastic Enclosure Around Contaminated Plenum

Photo 18 – Plastic Enclosure Around Contaminated Plenum

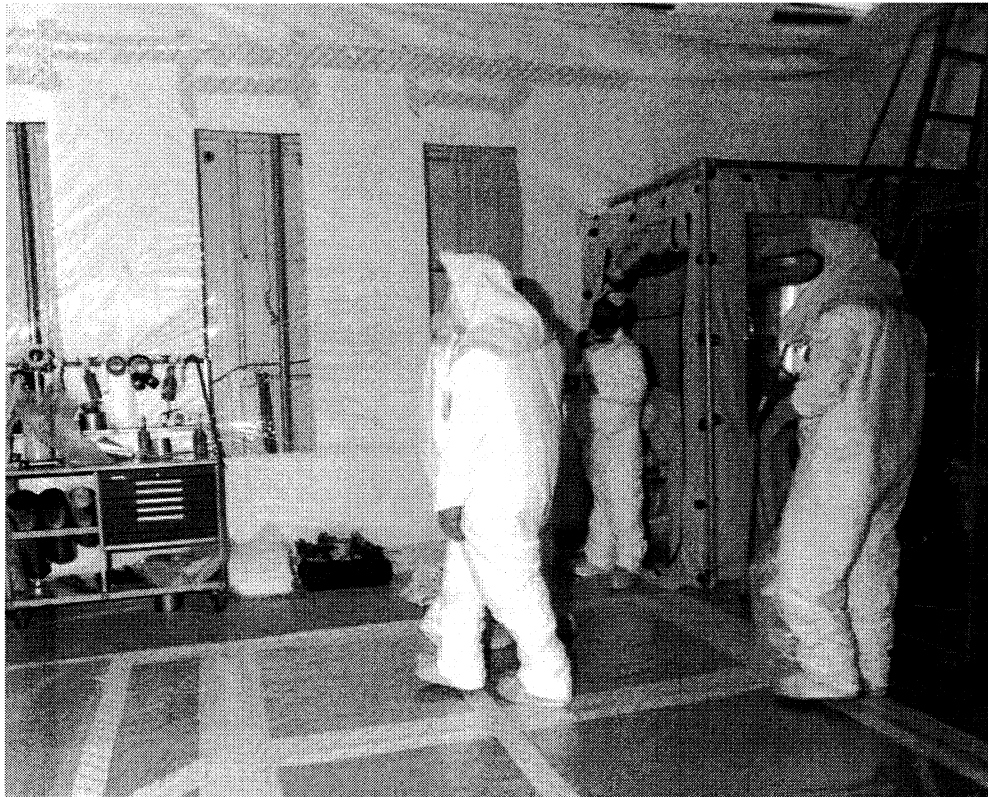
Photo 19 – Airlock To Enclosure

Photo 20 – Airlock To Enclosure

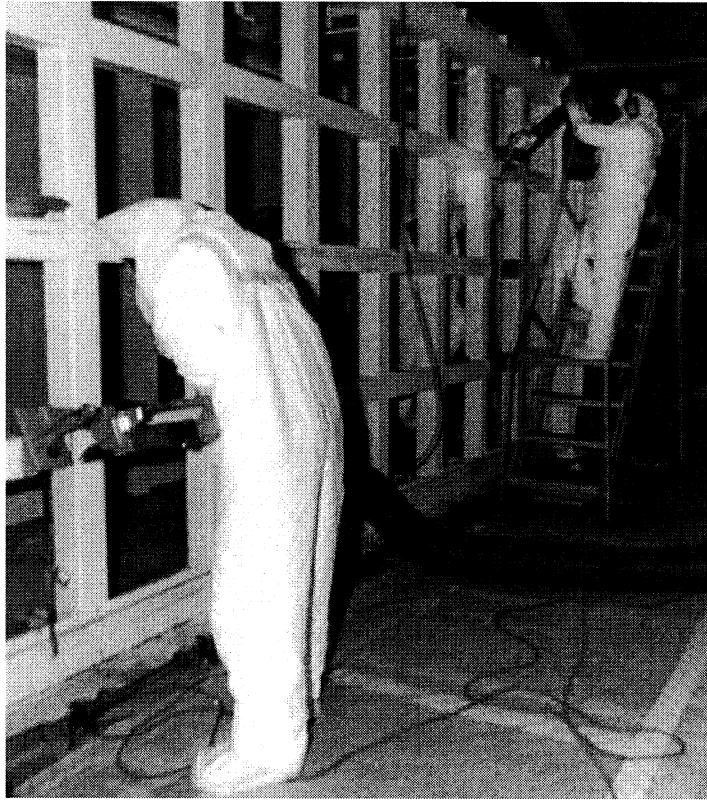
Photo 21 – Contaminated Plenum Demolition

Photo 22 – Contaminated Plenum Demolition
