Replacement of Inlet Vane Dampers

Dennis Otten

Nuclear Research and consultancy Group (NRG), Petten, the Netherlands

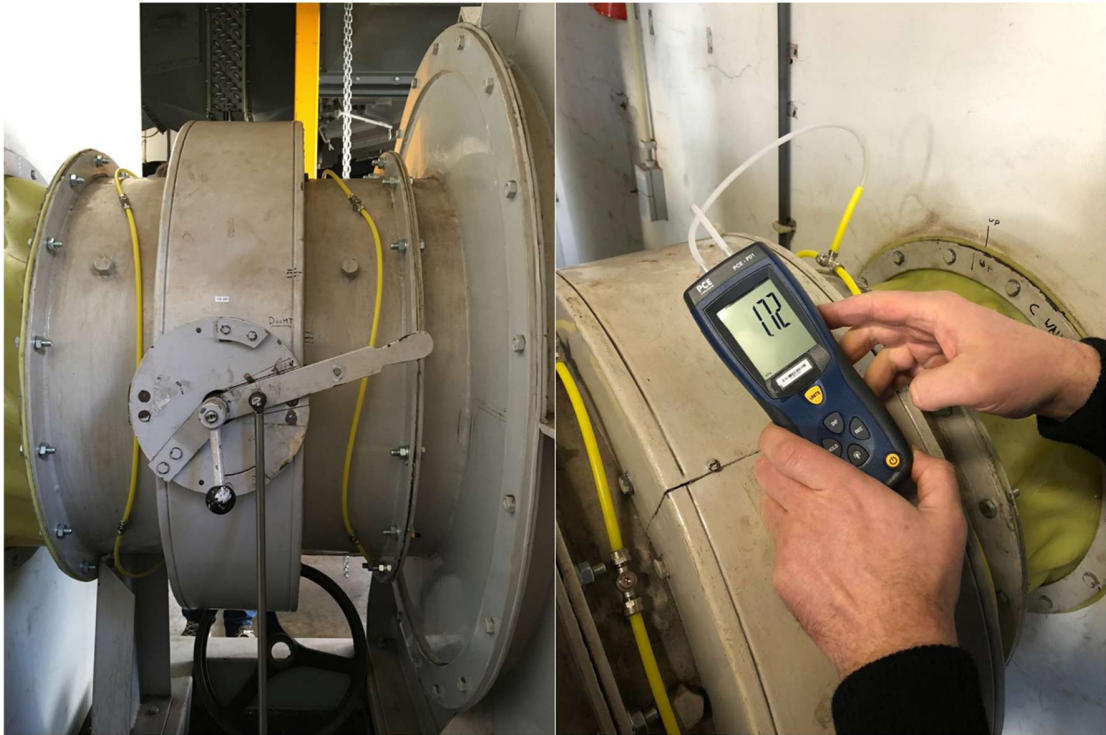
Figure 4 dp measurement taps installed and dp measurement being performed

- Measurements which were required for the design were specified to be done by the supplier. This changed during the contract formation and it was agreed that NRG would take the necessary measurements (dimensions and pressure drop). Due to a lack of resources within NRG, measurements took longer than anticipated, causing a delay in delivery. It also led to a change in size with increase in costs. Pressure drop across the IVD's also had to be measured. As previously mentioned, pressure drop in a fully closed and fully opened position was needed for the "like for like" replacement. Measurement facilities were not available, so these had to be created. Since the air up and downstream of the fan is very turbulent, a suitable measurement setup had to be designed. The supplier proposed to make a measurement tap in each quadrant of the IVD housing both up- and downstream of the damper blades. The four points were connected both up- and downstream to get an average value on each side of the damper blades. The pressure drop could then be measured by using a differential measurement device. The IVD's were operated from the pilot positioners to fully open and fully close the dampers. Unfortunately, due to the system setup and the state of operation of the IVD's, data was only collected for the fully opened position. In this position, data was logged for 5 minutes. Data was also collected from the flow transmitters within the ventilation system. Flow and pressure drop for the closed position was unknown. The supplier's proposed design deviated from the specification because the proposed design had an opening in the center of the IVD instead of the center hub. The pressure drop in the closed position would therefore be less than that of the original IVD's, causing a change in range. Since the IVD's are mounted in the exhaust systems and these systems fulfill the confinement function, this was accepted. A larger flow would mean a more negative pressure;

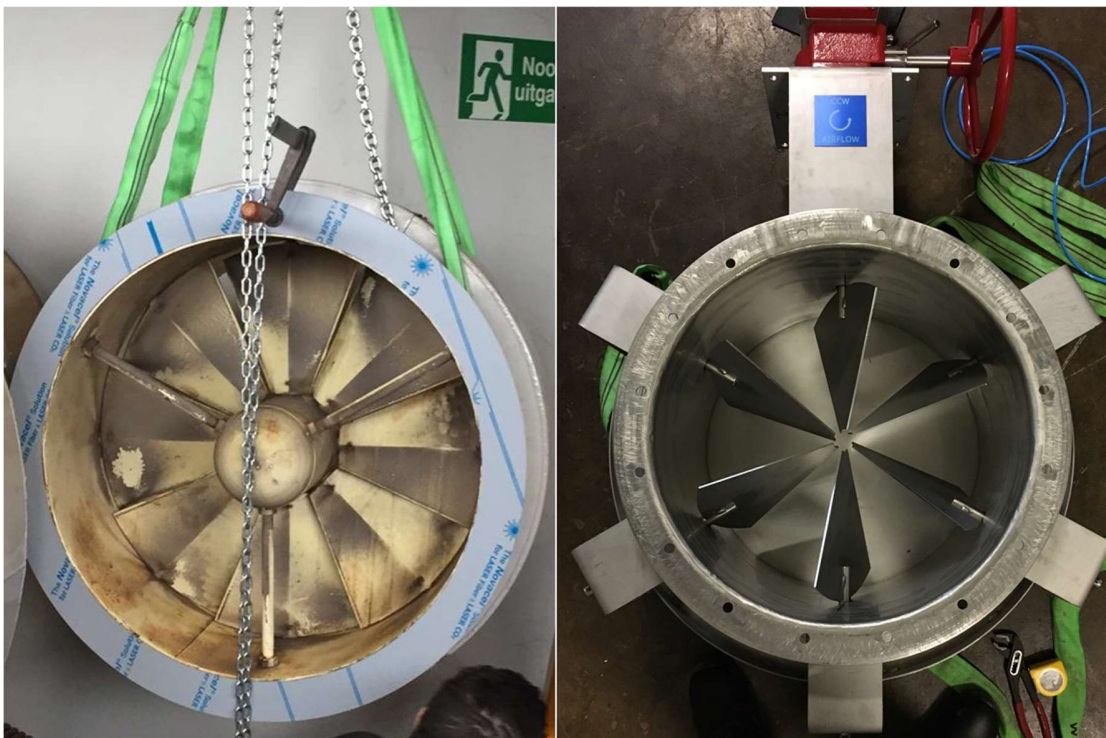
Figure 5 Original IVD on the left with center hub and new IVD on the right with center opening

During the design phase with the supplier, it turned out that they were unable to deliver according to the specification/ contract. Specified was an IVD with a center hub, but as this was not the supplier's typical design, they have proposed a design without a center hub. This meant that there was less pressure drop across the IVD's, resulting in a higher flow. This change was accepted by the project team, but without further internal approval, which meant a risk for the project. The impact of this change should have been documented by the project team first and then reviewed and approved outside of the project team. The change in range was eventually accepted because it meant a better capacity for confinement.
