24th DOE/NRC NUCLEAR AIR CLEANING AND TREATMENT CONFERENCE

POTENTIAL FOR HEPA FILTER DAMAGE FROM WATER SPRAY SYSTEMS IN FILTER PLENUMS*

Werner Bergman, Jan K. Fretthold¹, and James W. Slawski²
Lawrence Livermore National Laboratory
Livermore, CA 94550

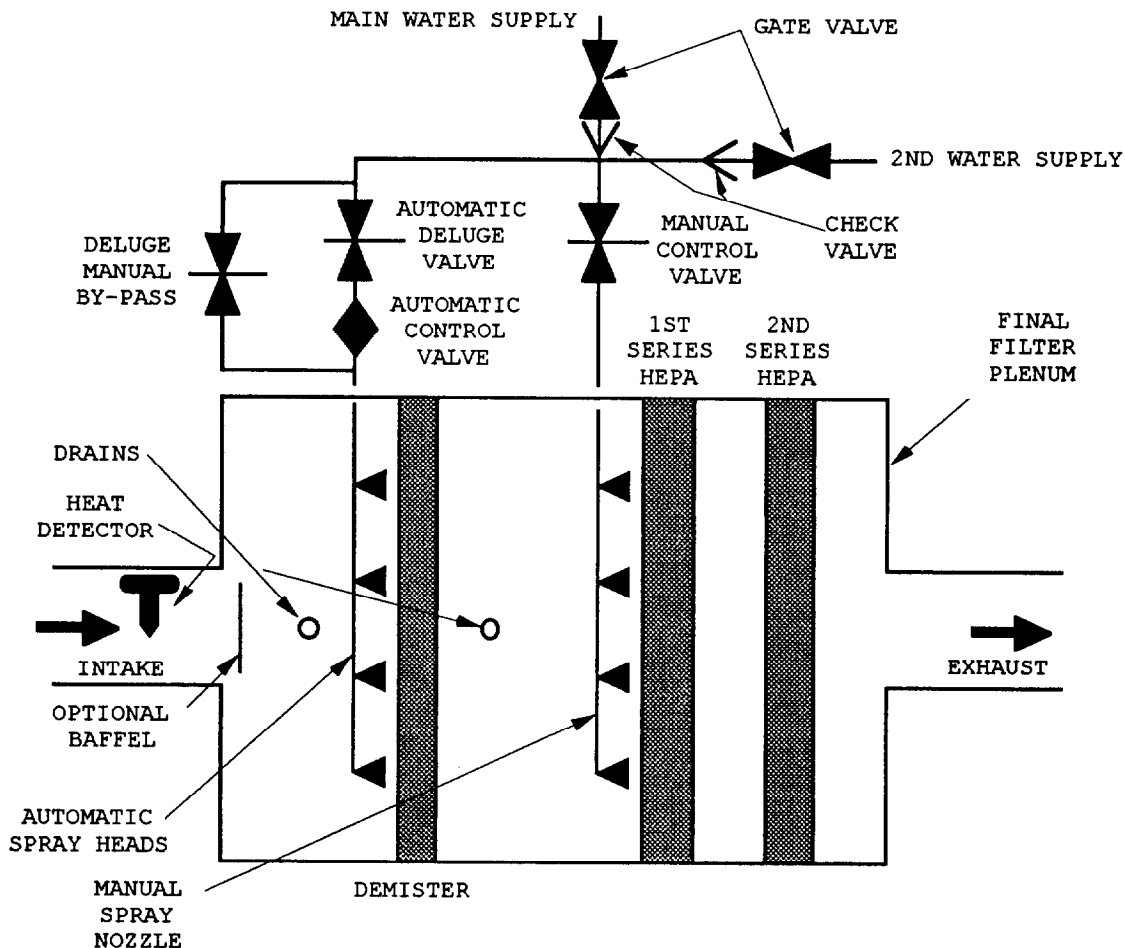
Figure 1 Diagram of the fire protection system for HEPA filter plenums widely used in DOE facilities and specified in DOE Standard on Fire Protection Design Criteria, DOE-STD-1066-XX ⁽⁷⁾

The 1980 filter plenum fire and the German studies on filter plugging with water sprays raise serious questions about the effectiveness of the water spray system shown in Figure 1 for protecting HEPA filter plenums from fires. The omission of key experiments in the early studies that led to the present fire protection system for filter plenums have perpetuated the belief that the system will work as designed. The early studies showed that water sprays followed by

The available studies on HEPA filter performance under fire conditions suggest there are problems with the current fire protection systems in filter plenums. Unfortunately there are no studies to confirm that the current fire protection system shown in Figure 1 will prevent the extensive filter blow-out seen in the 1980 Rocky Flats fire. German studies on filter blow out suggest that smoke and moisture can rapidly plug the filter plenum system in Figure 1 and result in filter rupture. We recommend an experimental study to confirm that the existing water spray system will work in protecting HEPA filters from rupturing during fires. Until this study is completed, we recommend that 0% efficiency be assumed for each filter stage exposed to a water spray if the blower has at least 10 inches of vacuum, disregarding the presence of a demister. This recommendation had been previously made in our guide for determining HEPA filter efficiency under accident conditions.⁽⁵⁾

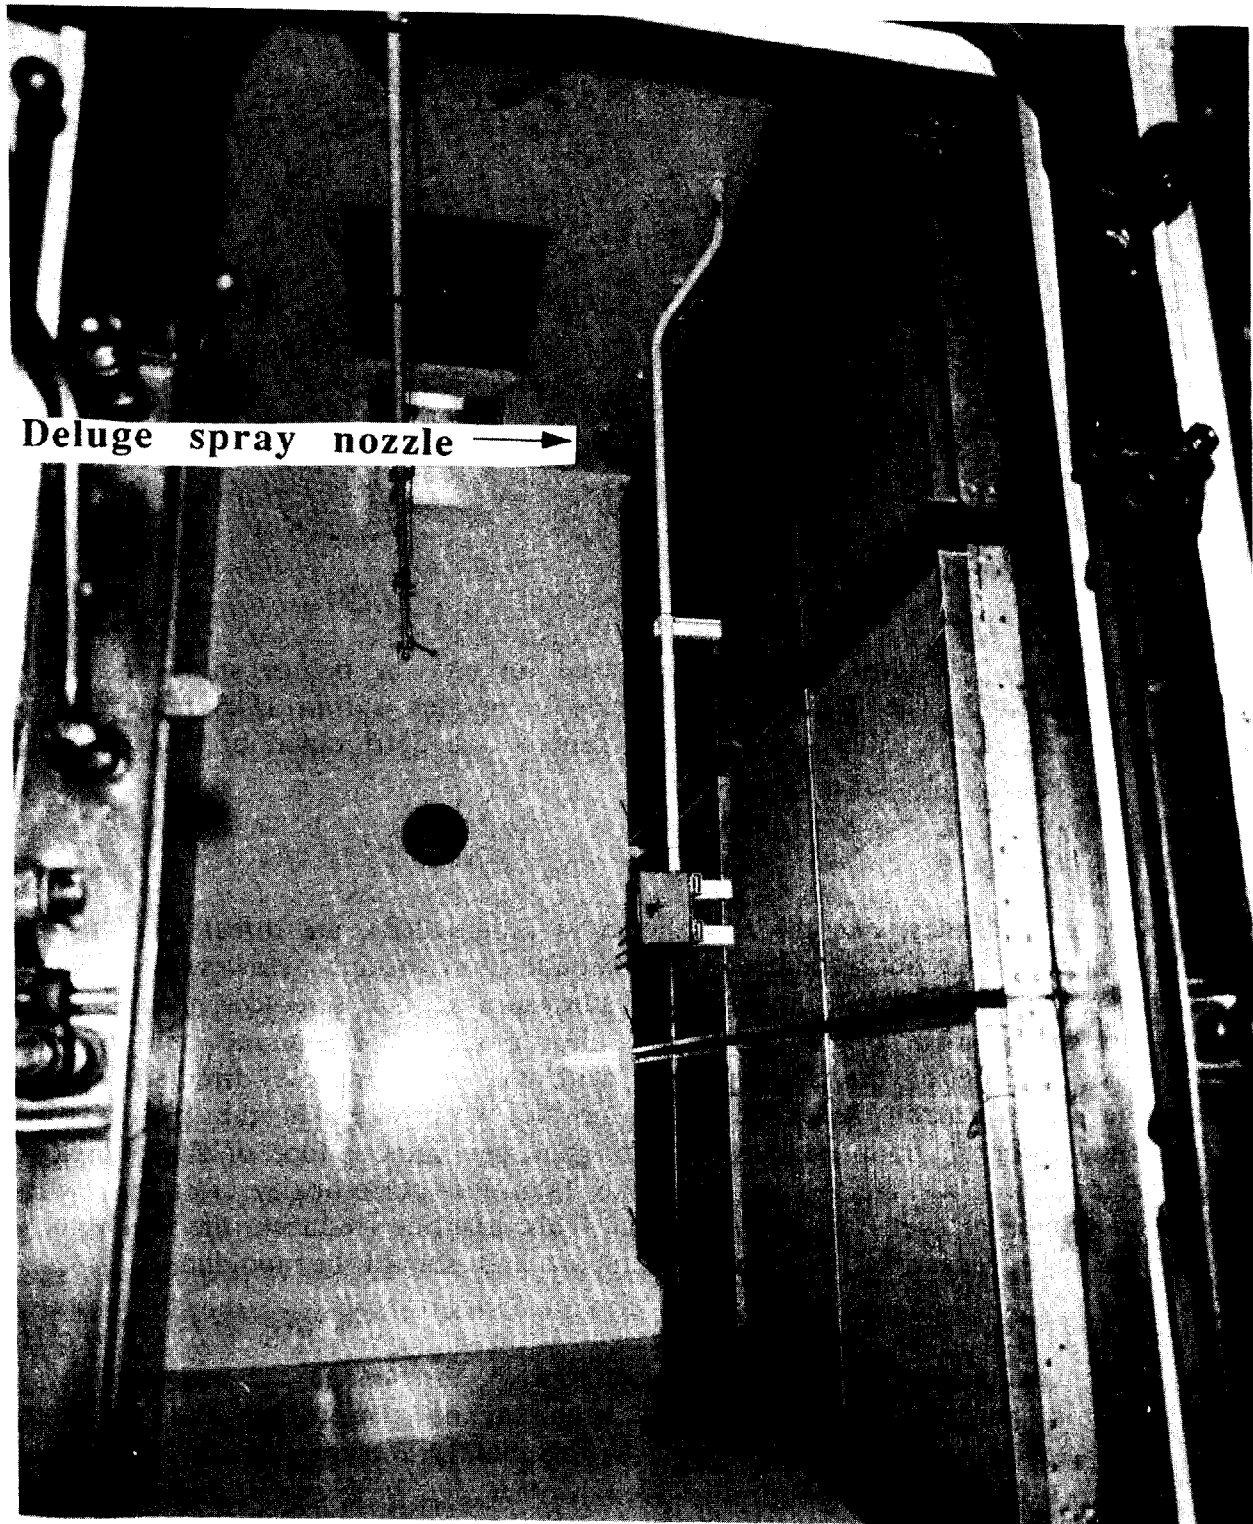
Figure 3. Photograph of a deluge spray nozzle mounted on the ceiling of a 4x4 HEPA filter plenum and located close to the inlet of the metal mesh demisters. The access door to the demister stage was opened for the photograph.

Although the use of a metal demister, as shown in Figures 1 and 3, improves the reliability of the fire protection system by cooling the air and removing water droplets, the HEPA filters can still be blown out because of smoke and water plugging. Ruedinger et al showed that HEPA filters can rupture due to absorbed water even when protected by demisters.⁽¹²⁾ Ricketts et al demonstrated that if a HEPA filter has particle deposits, it can rupture at relative humidities less than 100%.⁽¹³⁾ Since smoke aerosols can easily pass through demisters, the smoke and high humidity can result in rapid HEPA plugging and subsequent rupture.

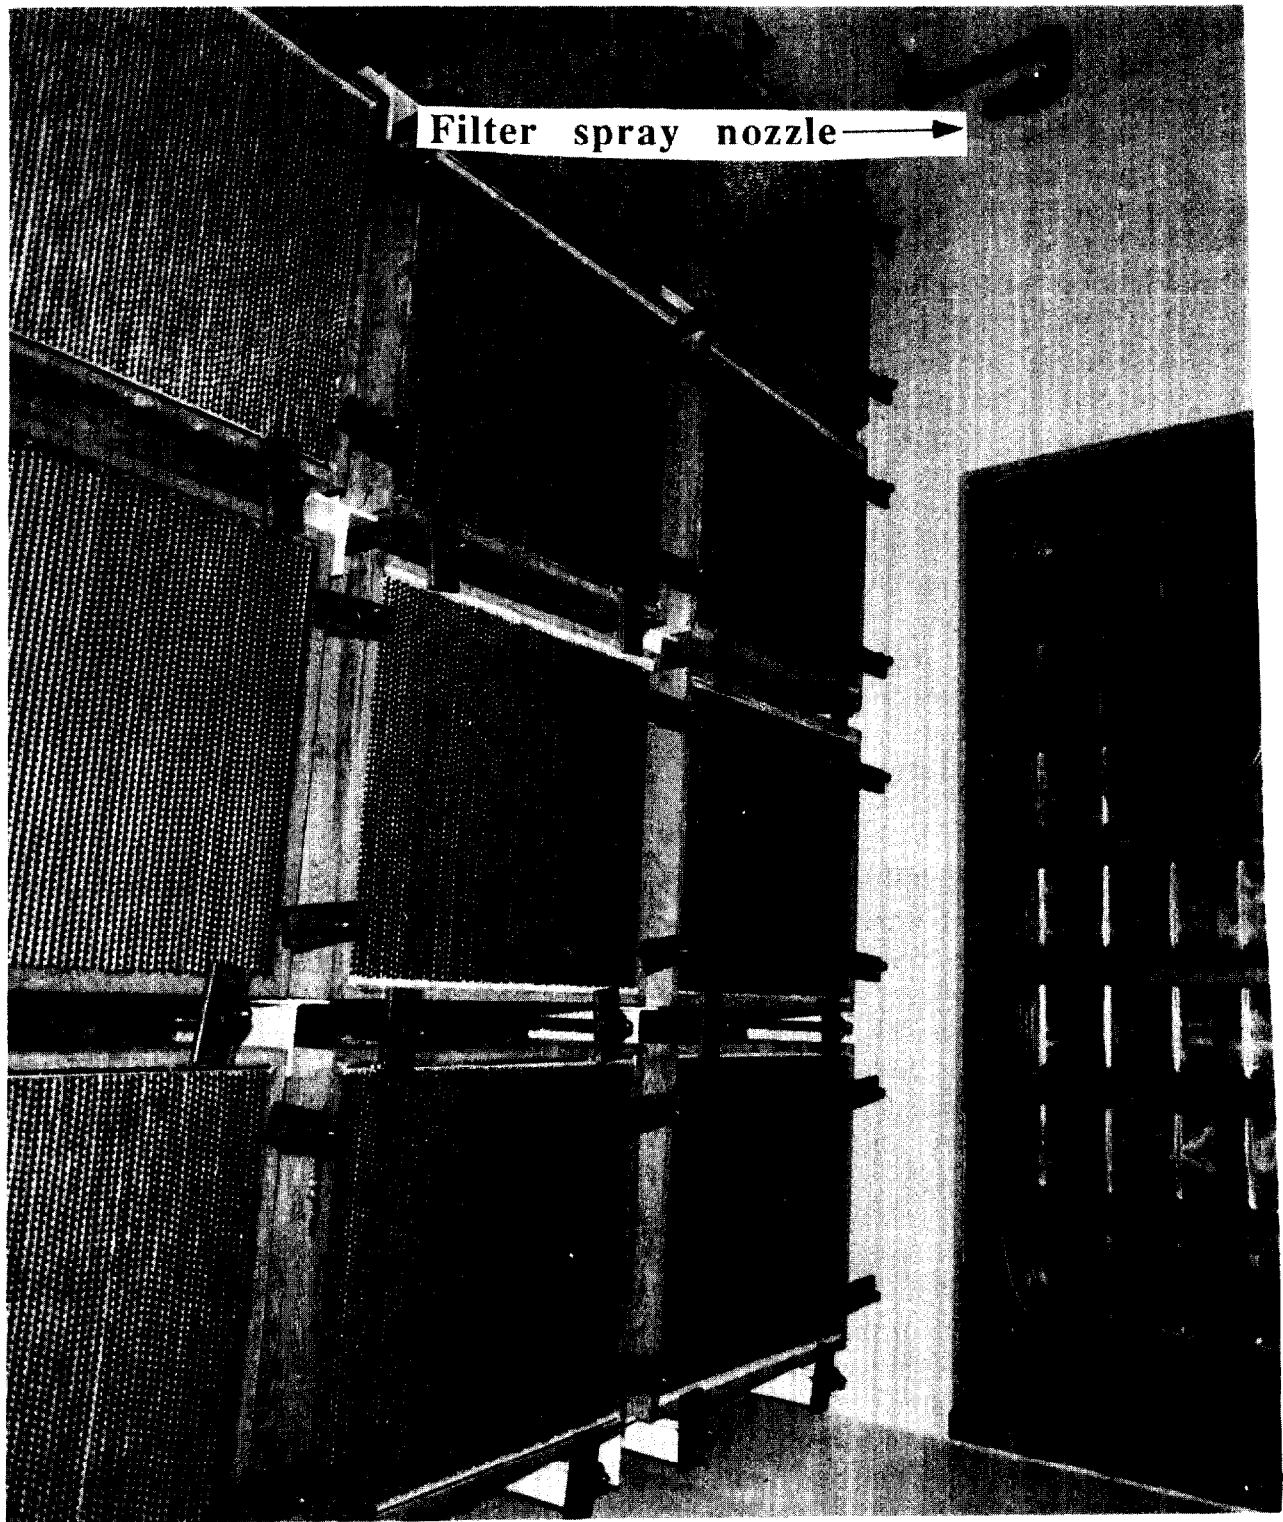
Manual spray nozzles, like the one shown in Figure 2(B), are directed at the first stage HEPA filters to put out potential fires should they occur. However, since the HEPA filters are easily damaged by direct water sprays, the selected nozzles must generate a fine water mist. Figure 4 shows a photograph of a manual spray nozzle mounted on the ceiling of the filter plenum with the spray nozzle directed against the first stage HEPA filters. A second spray nozzle is not seen in the photograph. The water flow through both nozzles is 0.25 gpm per square foot of filter area, or 16 gpm for the 16, 2'x2' HEPA filters. Some facilities periodically test the water spray and unavoidably wet the HEPA filters. This practice reduces the strength of the HEPA media as described later in this report and should be avoided.

Figure 4. Photograph of a manual spray nozzle mounted on the ceiling of the filter plenum with the spray nozzle directed against the first stage HEPA filters.

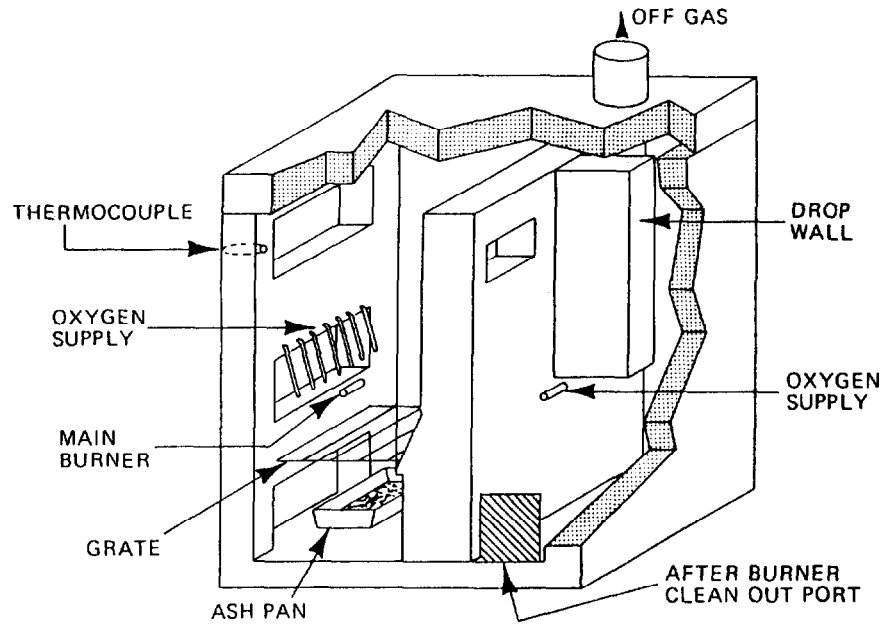
Fretthold described the results of a fire in a HEPA filter plenum at Rocky Flats that occurred on July 2, 1980.⁽²⁾ The fire occurred in a HEPA filter plenum that filtered the exhaust from an incinerator shown in the drawing in Figure 5. The exhaust from the incinerator is treated in an off-gas system in which the hot exhaust gas is first sprayed with a caustic solution to cool the gas and to neutralize the acid gases and then passed through a wet cyclone to remove suspended particles. Figure 6 shows the off-gas system. The treated exhaust then passes through a booster blower and into the incinerator filter plenum, as shown in Figure 7. A deflector cone at the plenum inlet deflects the incoming air to distribute the air more uniformly over the HEPA filters mounted 3 high and 4 across. Note that only 600 cfm passed through the plenum that had a filter capacity of 12,000 cfm. Although the filter plenum contained 4 stages of HEPA filters, the stages were incorrectly mounted back-to-back. The incinerator plenum did not have an automatic deluge spray system or a demister stage in front of the first HEPA bank. The exhaust from the incinerator plenum then enters the main building plenum.

Figure 5. Drawing of the Rocky Flats incinerator.

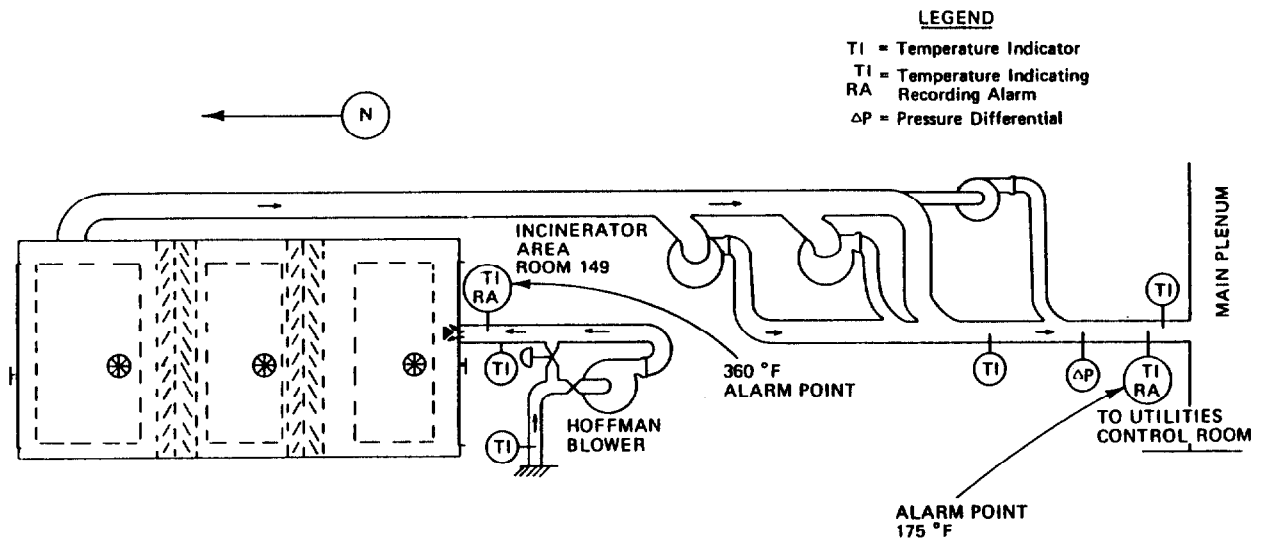
Figure 7. Incinerator filter plenum system

On July 2, 1980, a fire had occurred in the incinerator filter plenum and had extensively damaged the first three stages of HEPA filters and caused the fourth stage to severely bow.⁽²⁾ A continuous recording of the plenum inlet temperature showed the temperature was constant at 100°C for several hours prior to 11:00 A.M.. At that time the inlet temperature increased linearly with time until it reached a maximum 180°C at about 12:40 A.M.. At 11:30 A.M., the production foreman inspected the filter plenum and noted the plenum inlet temperature was 70° C, the differential pressure across the HEPA filters was 0.7 inches of water, and the plenum vacuum was 7 inches of water. These were normal readings. (The automatic temperature recording at 11:30 A.M. showed the inlet temperature was 110°C, not 70°C.) At 12:34 P.M., the alarm for the incinerator filter plenum sounded as well as the main filter plenum. The deluge spray also was automatically activated in the main plenum. Responding to the incinerator fire alarm, the utilities manager observed a red glow within the incinerator plenum and then activated the manual deluge sprinklers. Shortly thereafter, firemen arrived and also noticed a red glow in the plenum and that the manual water spray had been activated. They then attempted to enter the plenum with building water hoses, but could not open the airlock doors due to the high vacuum. After reducing the air flow, the firemen entered the incinerator plenum and sprayed the HEPA filter banks with a fine water mist. Photographs of the filter plenum in Figures 8-14 showed extensive HEPA damage.
