## CONDITION OF COMMERCIAL HIGH-EFFICIENCY FILTERS UPON RECEIPT OR INSTALLATION

### ABSTRACT

## FILTER RATING AND TESTING PROGRAM

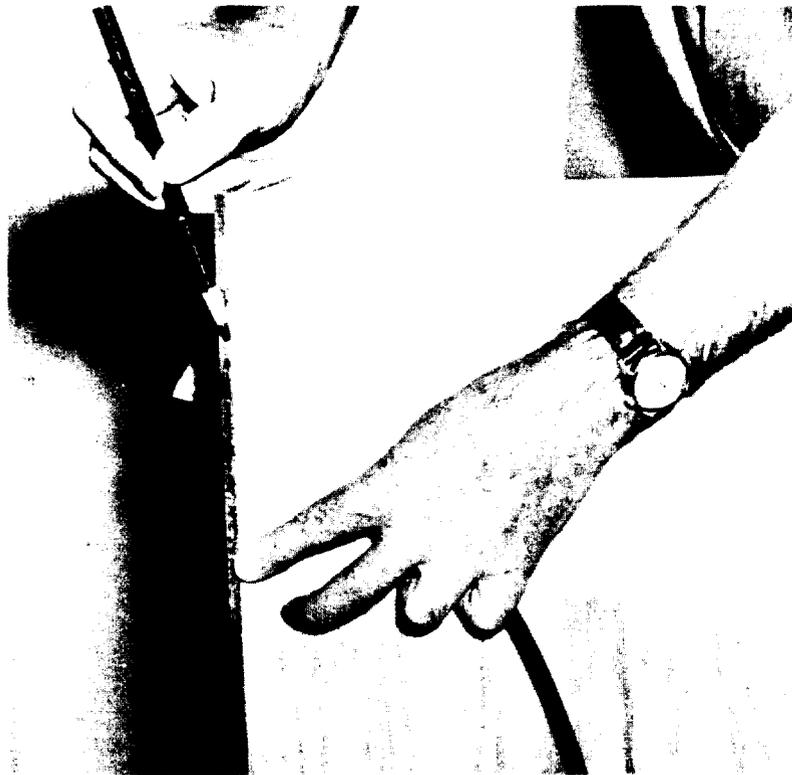
Picture No. 6—Gasket material. Note split in edge of gasket material.

2. See that the gasket is firmly cemented to the frame and that the gasket material is butted or meets at the joints and is itself undamaged. (Gaskets have been found with air-holes running through the sides of the material.)
